Analysis of Geomorphic and Hydrologic Characteristics of Mount Jefferson Debris Flow, Oregon, November 6, 2006

Scientific Investigations Report 2008–5204

By Steven Sobieszczyk, Mark A. Uhrich, David R. Piatt, and Heather M. Bragg

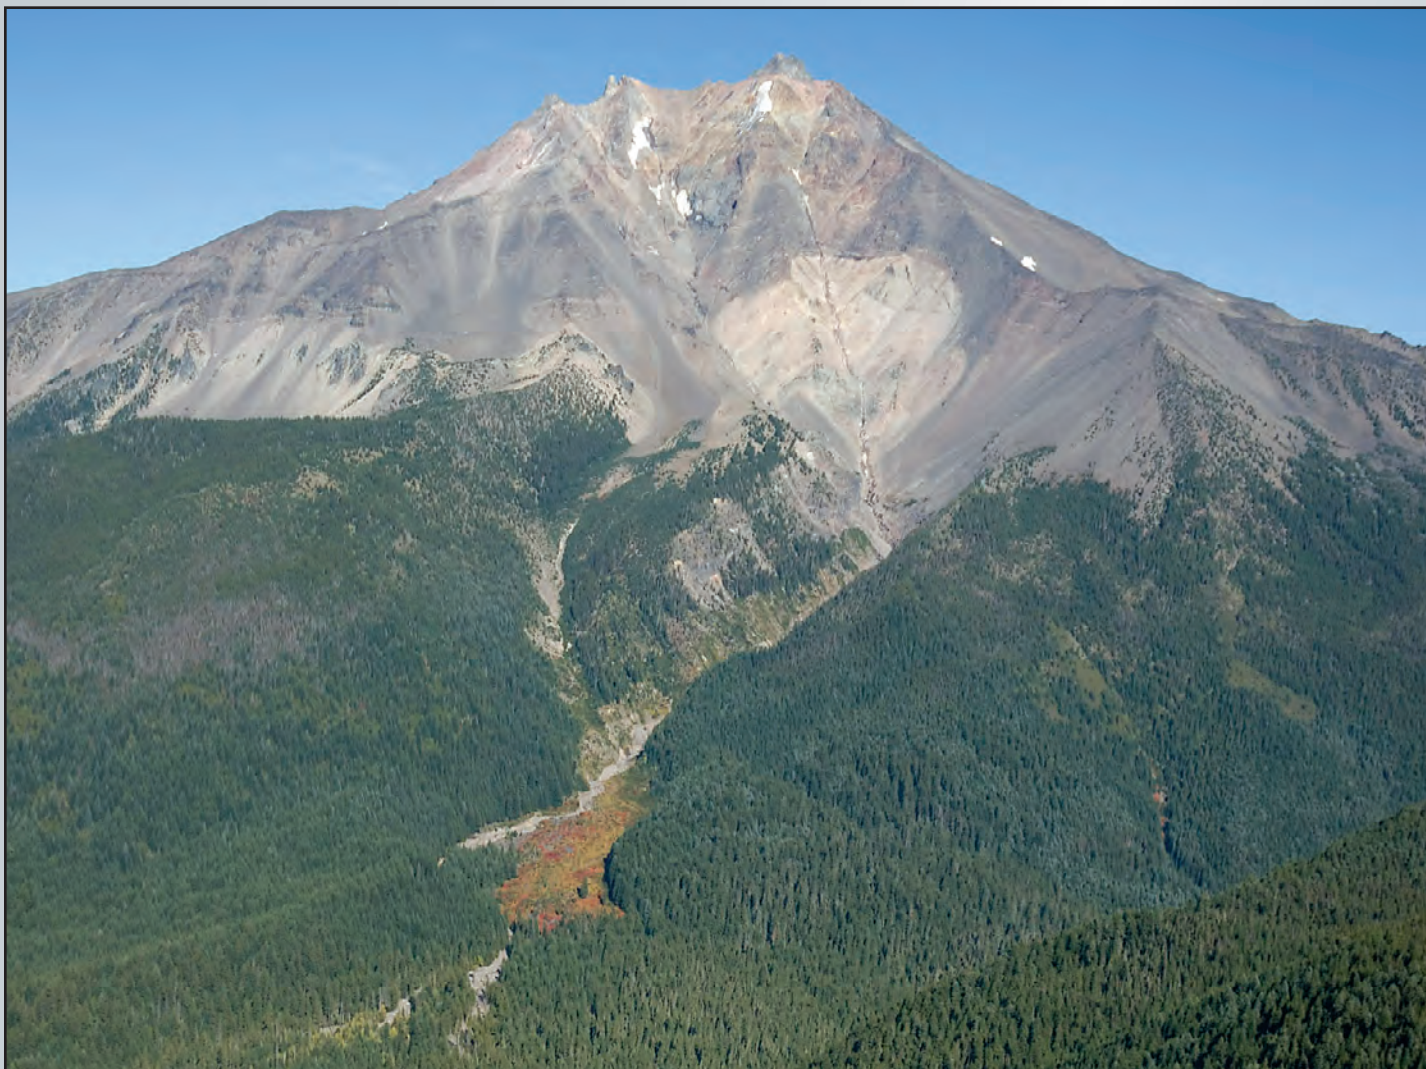
Front Cover: Photograph showing view of Mount Jefferson, Oregon, with the Milk Creek channel in forefront. Debris-flow deposit visible in light gray down center channel and into forest. (Photograph by Robert Ross, Linn Benton Community College, 2007.)

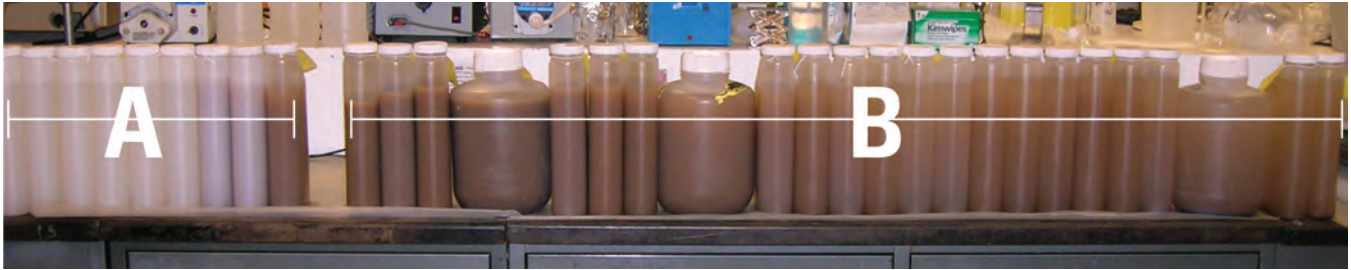
Figure 5. Automatic pumping samples collected at *North Santiam* water-quality monitoring station during the Mount Jefferson debris flow, Oregon, November 6, 2006. (Photograph by Heather Bragg, U.S. Geological Survey, 2007.) Gap between sample sets A and B occurred during bottle replacement.

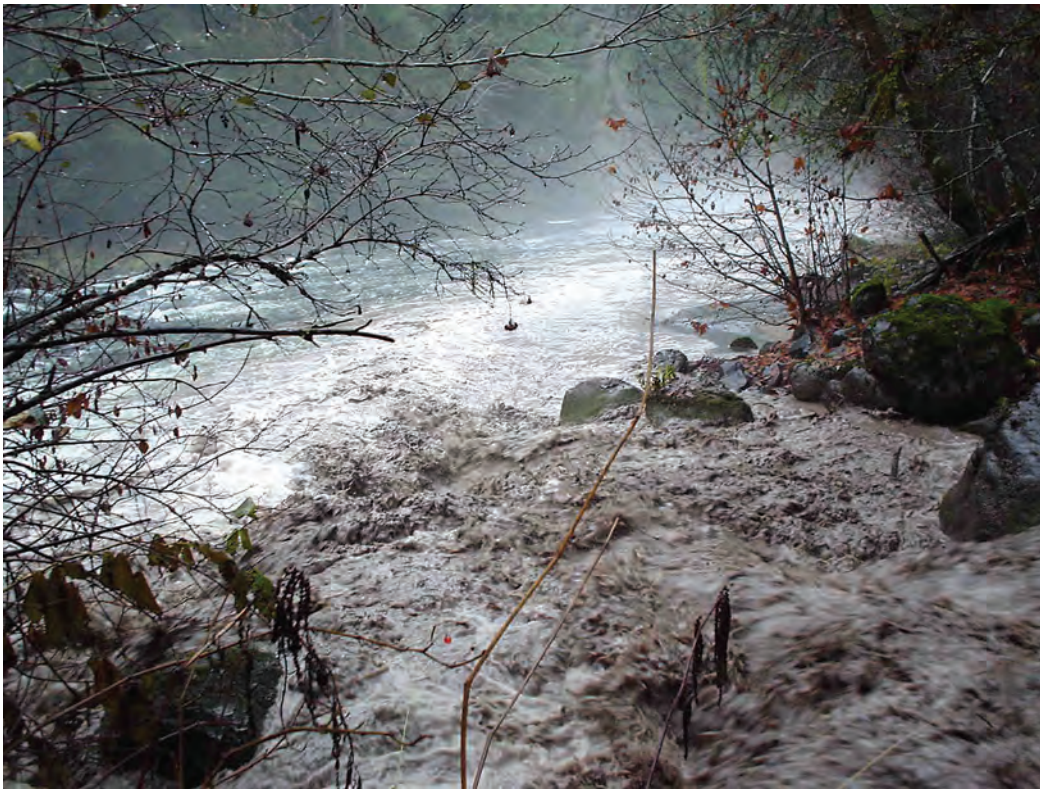
Figure 6. Streamflow from Pamela Creek entering the North Santiam River, Oregon, November 6, 2006. (Photograph by David Klug, U.S. Forest Service, November 6, 2006.)

Tracing the source of turbid water in the North Santiam River was facilitated by the fact that the tributary Pamela Creek, about 10 mi upstream of the monitoring station, was visibly turbid ([fig. 6](#)). USGS and USFS personnel investigating Pamela Creek discovered that a debris flow had mobilized down the Milk Creek drainage basin, supplying debris and sediment to both Milk and Pamela Creeks and beyond. Streamflow at Milk and Pamela Creeks remained extremely turbid for 12 to 18 hours during the debris flow event-period on November 6.

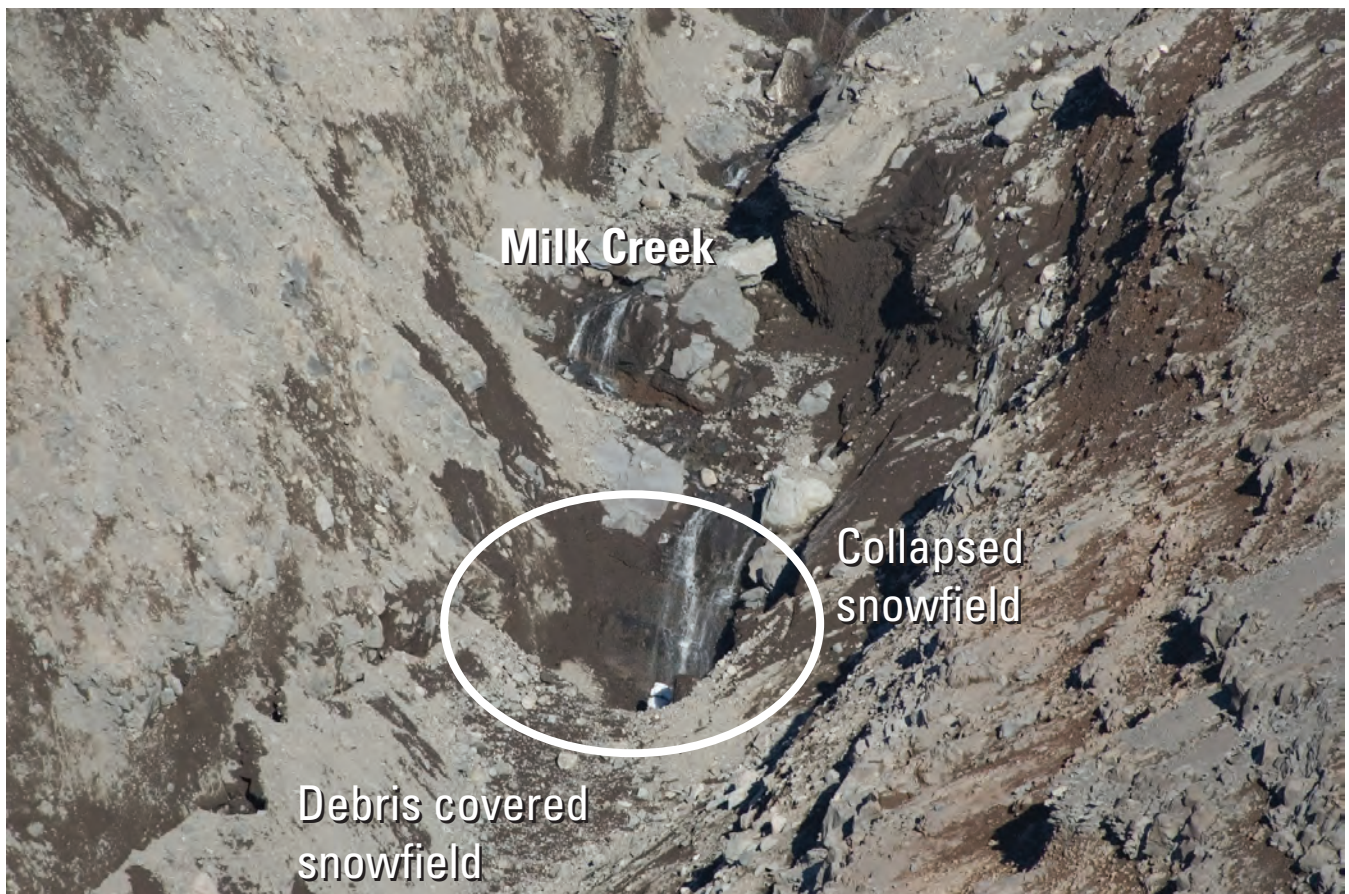
Figure 7. View of debris covered snowfield in the Milk Creek channel, some of which collapsed and melted, supplying material for the Mount Jefferson debris flow, Oregon, November 6, 2006. (Photograph by William Myers, Oregon State University, 2007.)

of mechanisms. Although rainfall influenced the debris flow, noticeable changes in high altitude Milk Creek snowfields, as observed by USFS and USGS, indicated that the debris flow likely mobilized after the collapse of part of a talus-covered stagnant valley snowfield ([fig. 7](#)). This type of proglacial collapse and flooding occurred during previous times and at other Cascade volcanoes (for example, Scott and others, 1995; Walder and others, 1999; O'Connor and others, 2001). Although the rainfall may not have initiated the debris flow, it did increase melting of surficial snow, amplified runoff, saturated sediments, and augmented subsnowfield streamflow. Snowfield calving and sediment unloading likely started relatively small, but continued to accumulate and erode more material as it progressed downstream ([fig. 8](#)). Because of the presence of older debris flow deposits in the area, much of the loose, previously deposited material was easily remobilized by this recent event.

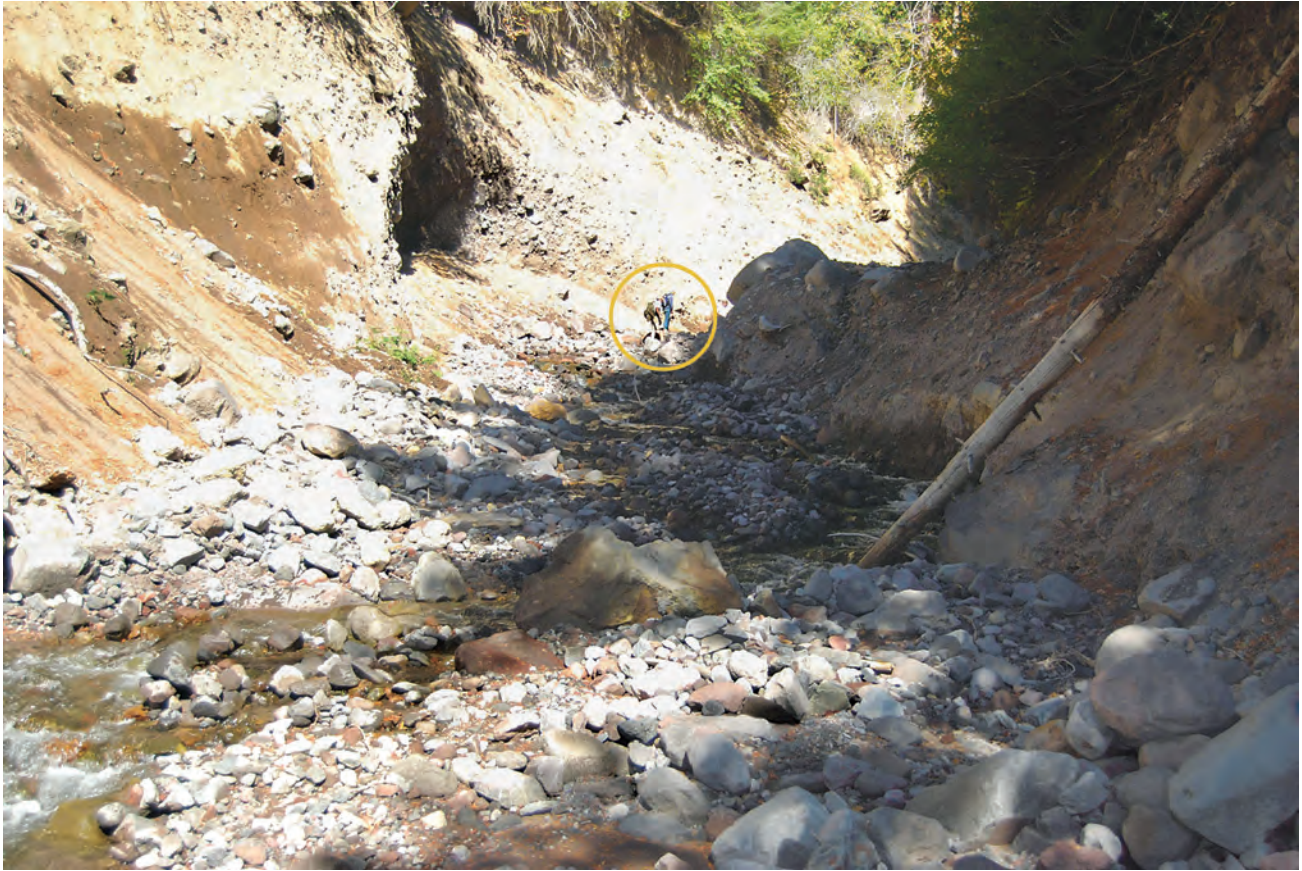
Figure 8. Channel incision along Milk Creek, where debris flow gained volume during the Mount Jefferson debris flow, Oregon, November 6, 2006. Note people for scale. (Photograph by Mark Uhrich, U.S. Geological Survey, 2007.)

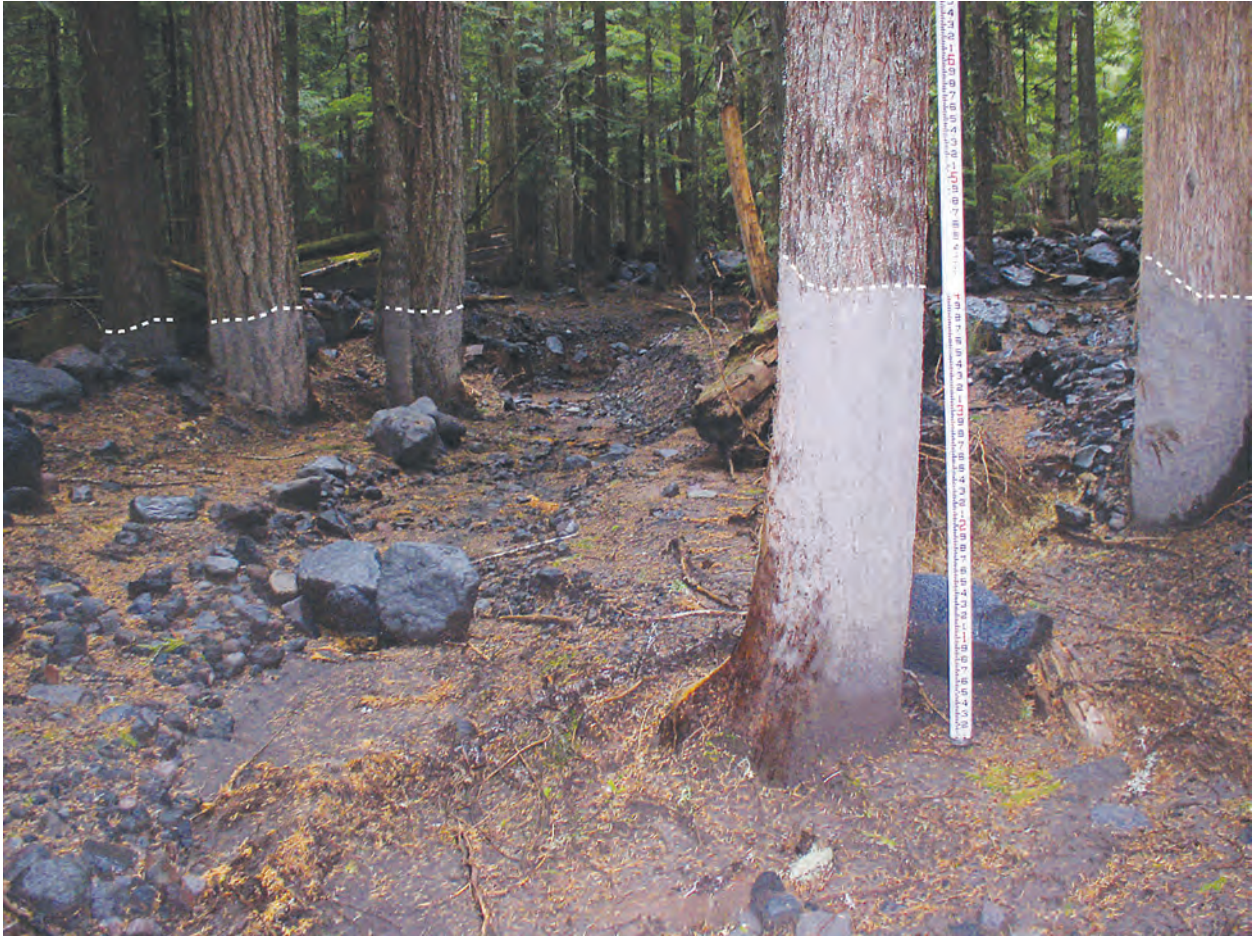
Figure 9. Mud run-up markings on trees created by flooding associated with the Mount Jefferson debris flow, Oregon, November 6, 2006. (Photograph by Mark Uhrich, U.S. Geological Survey, 2007.)

confined, high altitude channels ([table 2](#)). As the flow spread across the valley floor, tree markings displayed a reduction in stage height to 1 m or less. High flows associated with flooding remobilized boulders and debris along Milk and Pamela Creeks, as well as deposited sand and silt across the forest floor. Flooding and high flows eroded portions of the initial debris-flow deposit and other older deposits, reworking much of the landscape. As velocities decreased, greater volumes of fine-grained sediment were deposited within distributary channels along the Milk and Pamela Creek drainage basins. After the debris flow slowed and deposited its coarse material, the sediment-laden streamflow continued to the North Santiam River and Detroit Lake. This type of debris-flow-induced flood surge was consistent with previous events on other Cascade volcanoes (see, for example, Scott and others, 1995; Pierson, 2005; National Park Service, 2007).

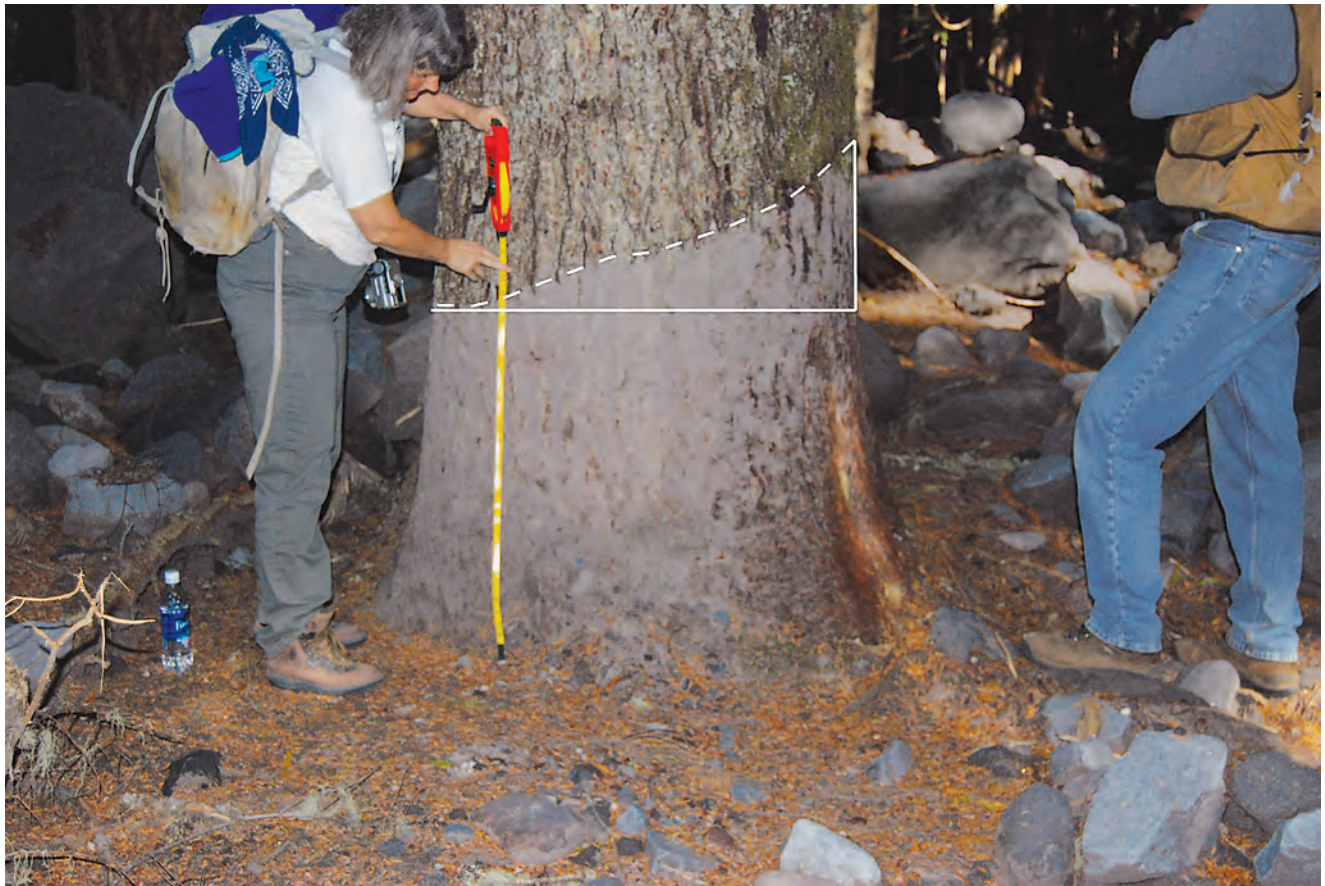
Figure 10. Change in height of mud run-up markings created by debris flow and flooding impacting tree (left to right) during the Mount Jefferson debris flow, Oregon, November 6, 2006. (Photograph by Mark Uhrich, U.S. Geological Survey, 2007.)

The Mount Jefferson debris flow in November 2006 was not a single flow event, but rather a series of at least three or more surges of debris and flooding (David Halemeier, U.S. Forest Service, written commun., 2008). Evidence of damming and redirection of flow, channel terracing, and deposition then scouring of material all support this hypothesis. Because this event comprised multiple flows, calculating one specific velocity was impossible. Instead, using field measurements of change in height of mud run-up on trees ([fig. 10](#)) and observations of material type, an indirect velocity equation (Jakob, 2005) was used to calculate a range of values for this event. For this study, mud run-up markings for 22 trees were measured at different locations in the depositional area ([table 2](#)). The deposit material type was initially coarse and boulder-sized before thinning to a mud slurry. Based on these observations, velocity was determined by an equation for “rocky”-type debris flows proposed by Chow (1959). The equation describes debris flow velocity

in relation to the change in run-up height multiplied by a multiple of the gravitational constant (Chow, 1959, eq. 1). Two known limitations for this equation are (1) it only applies to impacted objects perpendicular to the flow direction, and (2) it assumes all kinetic energy was converted to potential energy (Jakob, 2005). Theoretical run-up equations, such as equation 1 in Chow (1959), also yield velocities as much as 30 percent lower than large-scale flume experiments (Jakob, 2005). However, given the data available, these velocity calculations offered tangible values for discussion and comparison.

$$v = (2g\Delta h)^{0.5}, \quad (1)$$

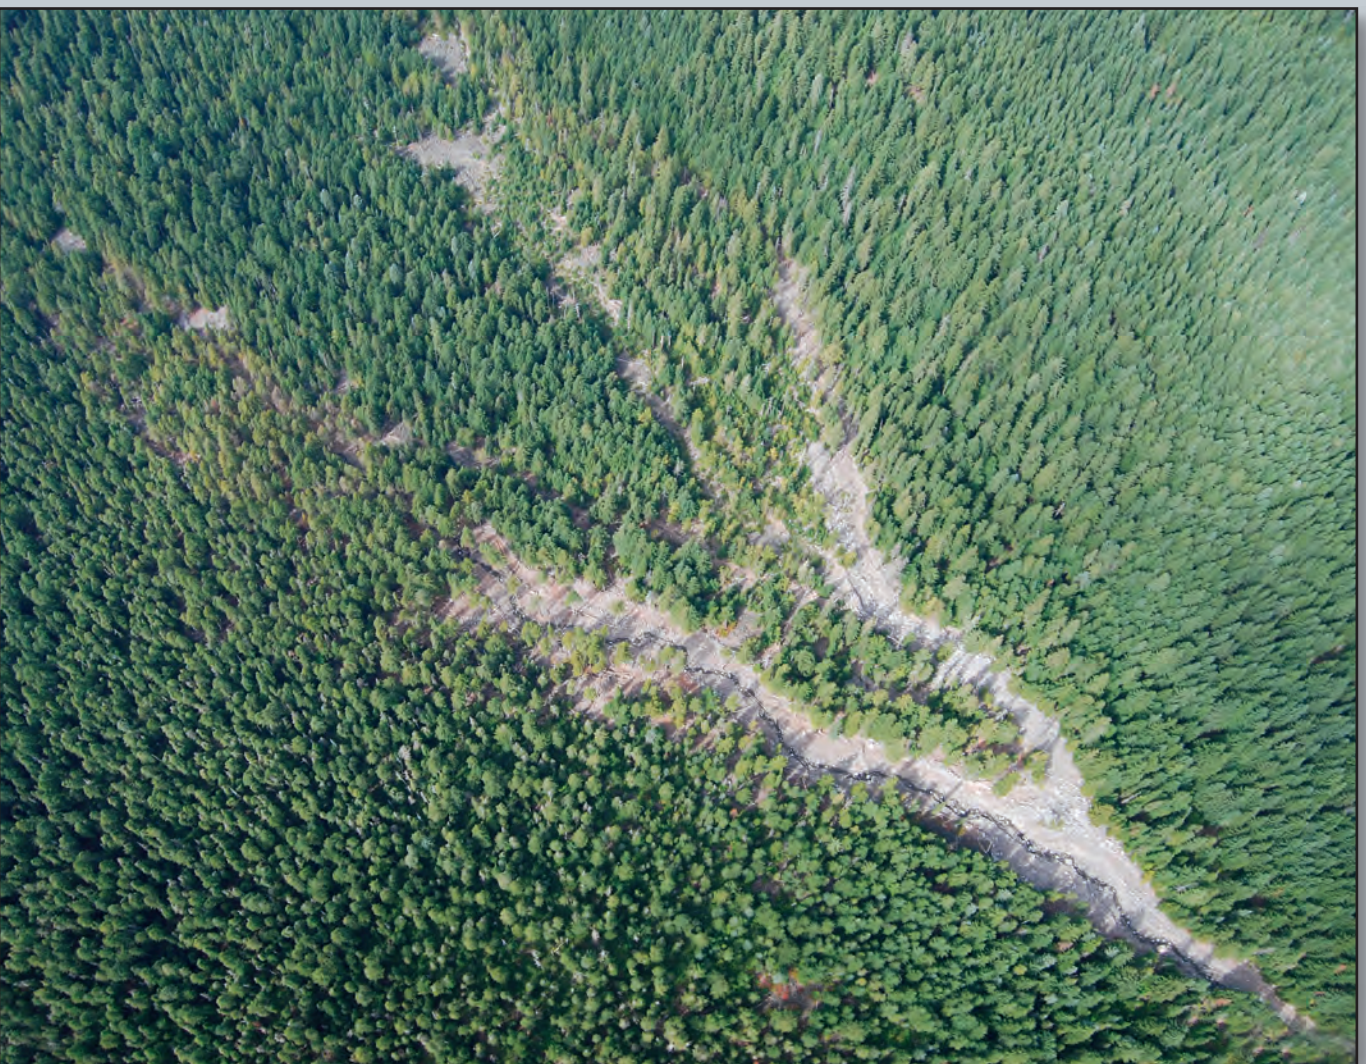
Back cover: Photograph showing newly deposited material (light gray) in the Milk Creek drainage basin, Mount Jefferson debris flow, Oregon, November 6, 2006. (Photograph by Robert Ross, Linn Benton Community College, 2007.)
